PLANNING DIVISION  
*HISTORIC PRESERVATION*

**STEP 2: DETERMINATION of whether to PREFERABLY PRESERVE**

**Site:** 55 Heath Street – Carriage Barn only  
**Case:** HPC.DMO 2020-11

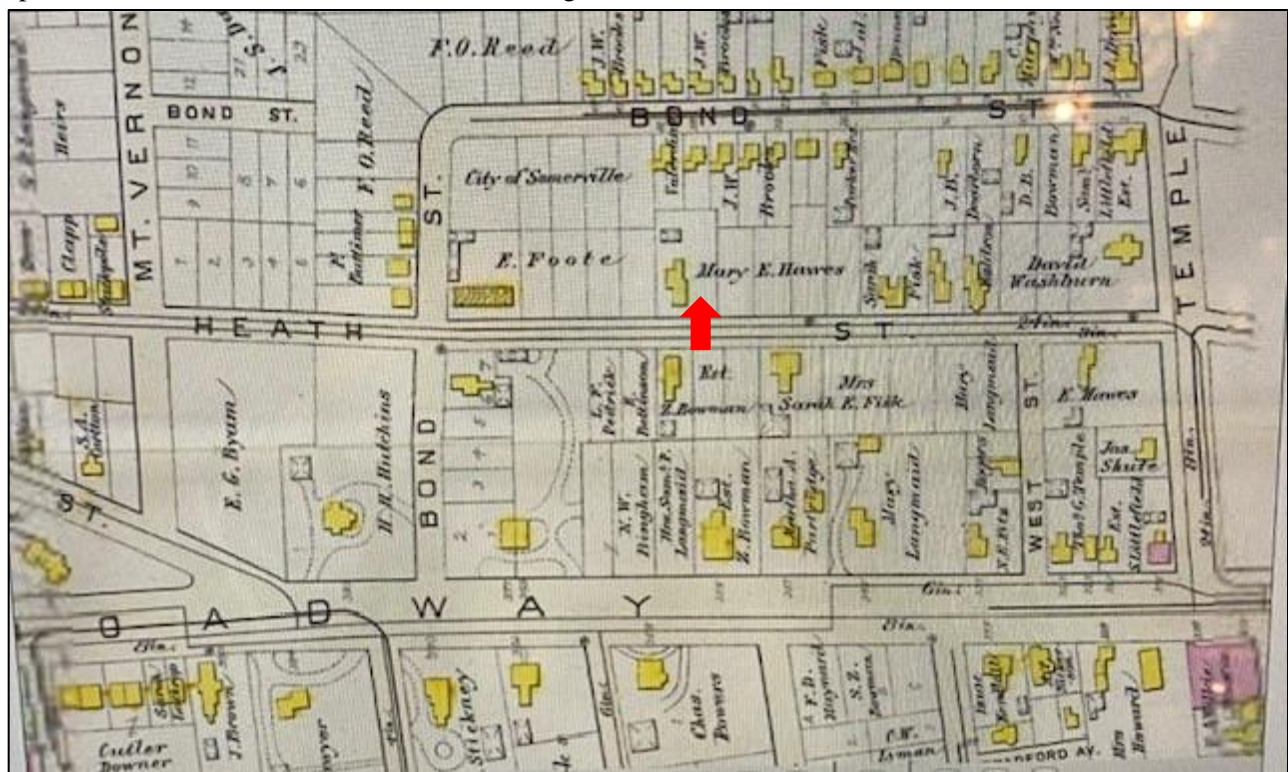
Above, Hopkins Plate 011, 1884

By 1884, as the Hopkins plate below shows, the ownership of the tract of land has changed to Mary E. Hawes and the barn has been built behind the dwelling house. The rectangle with an “x” on the Hopkins plates indicate stables, which is how the carriage barn at 55 Heath has been marked.

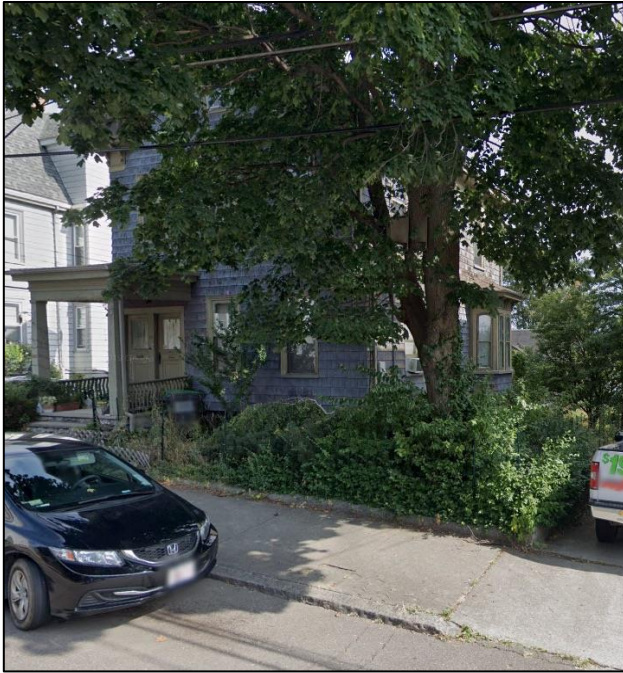
Portions of this structure are visible from the public way of Heath Street. The left addition and the left side gable are visible when looking down the left side of the property from Heath Street. The right side gable and a portion of the center gable are visible when viewing the property along the right elevation from Heath Street, both when the deciduous tree in the side yard is in full leaf and during the months when the tree is devoid of foliage in the late fall and winter months. See photos below.

*Above, left and right: view to right gable end and portion of center gable from Heath Street.*

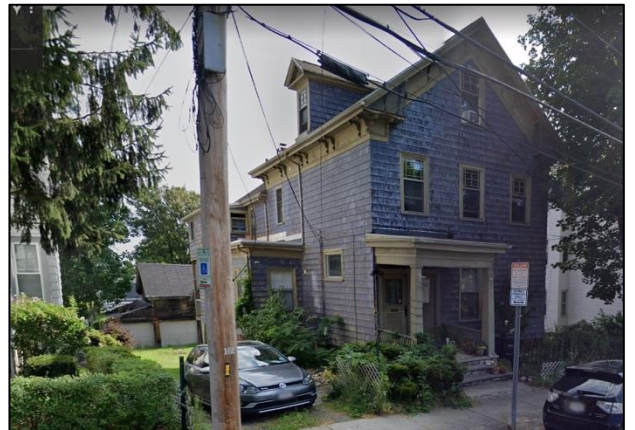
*Bottom, right: view to left gable end and addition from Heath Street.*
